Improper agricultural practices lead to landslide and mass movement disasters: A case study based on upper Madi watershed, Nepal

Anup Gurung¹, Om Prakash Gurung², Rahul Karki³ and Sang Eun Oh^{1*}

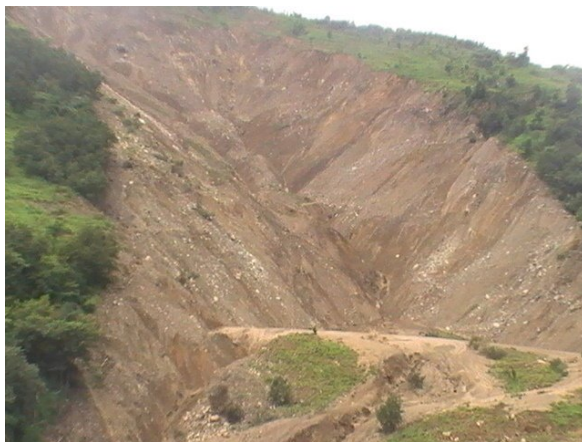
On 3 August 2010 the “Nang Nung” of Taprang which is commonly called as “Taprang ko Pahiro” (Pahiro means landslide in Nepali) experienced an unprecedented landslide and channelized debris flow powered by the Madi river. According to the local dwellers, there was sustained rain over the preceding few days and heavy rainfall and higher stream discharge was observed on the evening of 2 August 2010. There was thunder and lightning and the area experienced threatening noise and ground shaking approximately on the early morning (5:00 am) of the day of the incident day. The landslide or mass movement occurred shortly after the cessation of the sounds and shaking; at 8:45 am of 3 August 2010. The sudden surge of debris flow inundated the part of the Madi river and carried much of it into the Madi river thereby blocking the river. Field observations confirmed that this landslide was shallow and mostly translational in nature, and expanded 1,600 m in length and 600 m in width, respectively (Figure 2). On the other hand, the Madi river was blocked by the debris (logs and sediments) for several days (20 days) particularly at the narrow sections of the channel resulting drastic change in the morphology of both the channel and flood plains even far downstream areas during this period (Figure 3).

Figure 2. Nang Nung Taprang landslide.

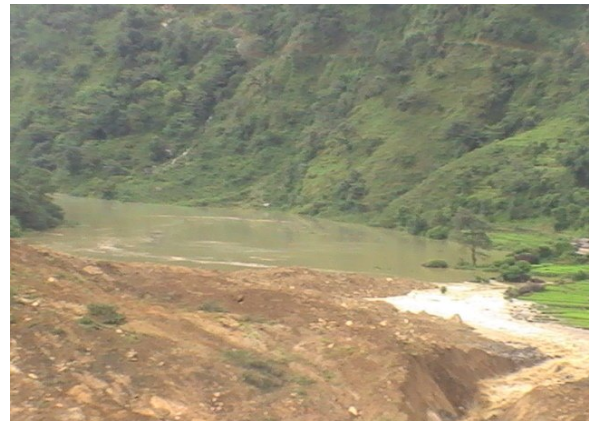
The water volume in the Madi river increased tremendously resulting a lake with width 80 m, length 1,500 m, and depth of 5 m, respectively. Additionally, due to blockage of the river, the water

Figure 3. Blockage of Madi river by the debris flow in Nang Nung Taprang.

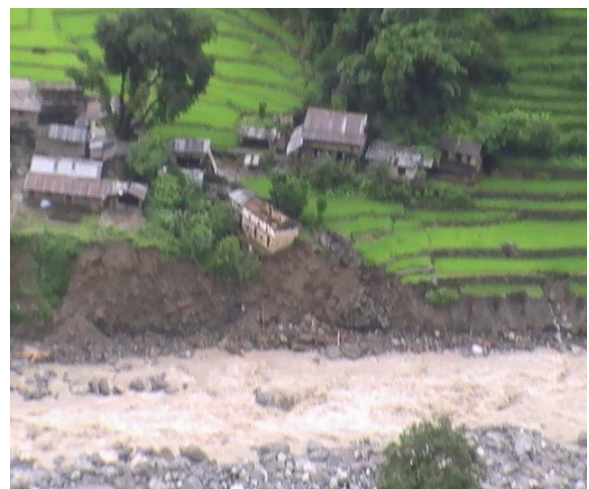
had collected nearly in 3 km of the river section. The landslide claimed life of five people, two of them were school children from Taprang and three of them were from Sikles heading towards Pokhara. The landslide caused high levels of economic loss and substantial numbers of fatalities in the area: 6 people were wounded, 72 households were displaced (61 from Taprang and 11 from Seti Khola), 59 households were partially damaged, 58.4 ha of agricultural land were swept away, 1.5 km of Kahu Khola - Dudhpokhari Rural roadway had been swept away, a suspension bridge was swept away that used to connect Namarjung VDC with Sildujare VDC, and many social infrastructures like school, community buildings, post office, and other physical structures were damaged (Figure 4).

Figure 4. Houses washed away by torrential flood in Sondha.

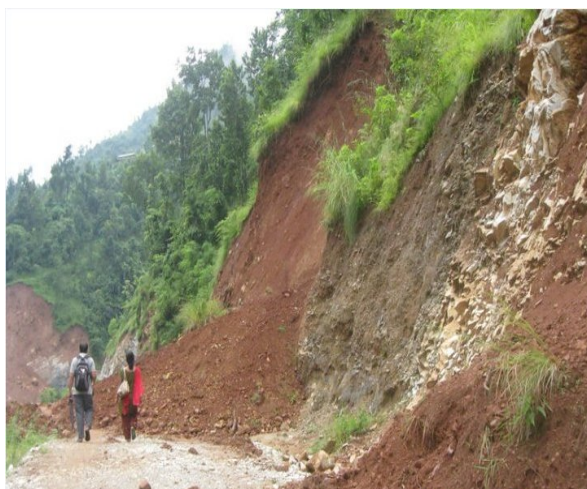
Approximately 1.5 km walking trail (from Taprang to Sikles) was washed away by the floods. 200 houses were evacuated in the affected area due to blockage of the Madi river (Figure 5). In addition, the blockage of the Madi river affected the downstream VDCs such as Ghumle Bazar, Chanchu, Bhainse, Majhthana, Hansapur, Thumki, and Mijure (Figure 6).

Figure 5. Disruption of gravel road due to landslide in Taprang.

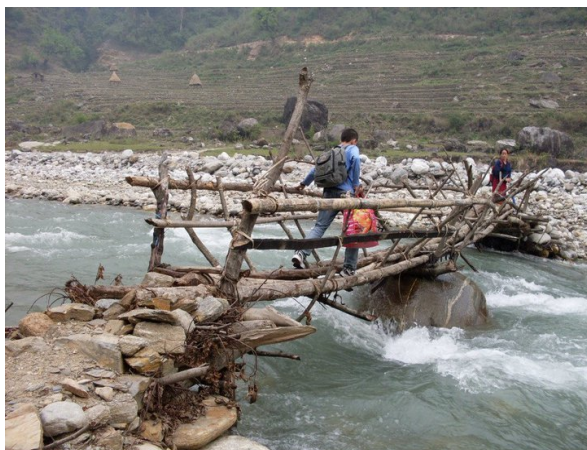
Figure 6. Temporary bridge in the Madi river after the suspension bridge has been washed away.
